Important considerations in applying X-ray Microanalysis techniques for the diagnosis of outdoor copper based monuments

V. Argyropoulos*, A. Vossou, K. Polikreti, D. Charalambous,
I. Sianoudis, A. Karydas, V. Perdikatsis, S. Bittner, and M. Mach

Kolokotronis in Nafplion and Athens

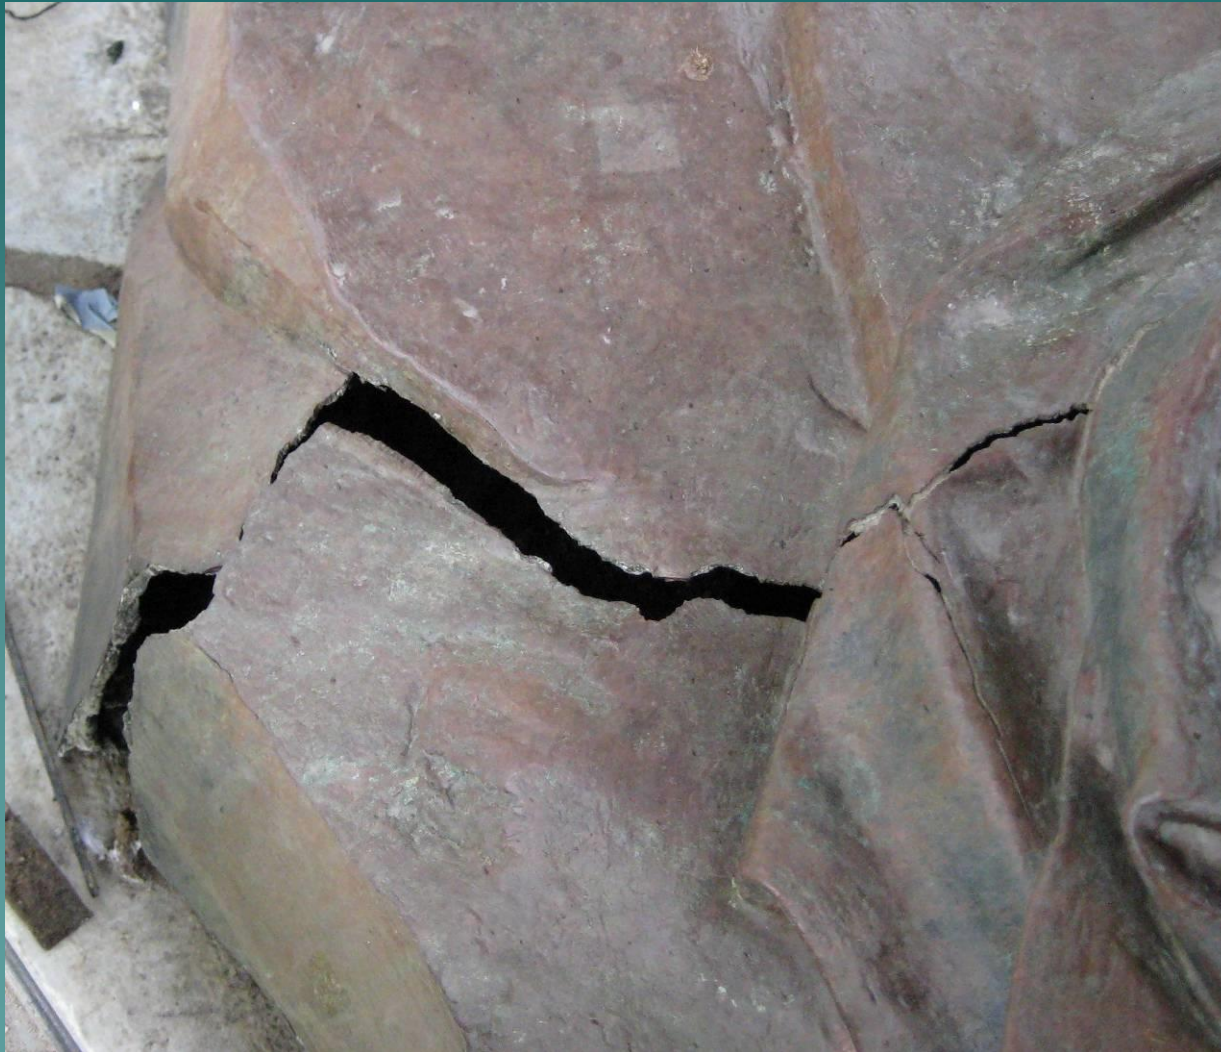
cracks - disequilibrating actions within the sculpture. the plinth is not able to absorb the complete weight of the overlying parts of the monument.

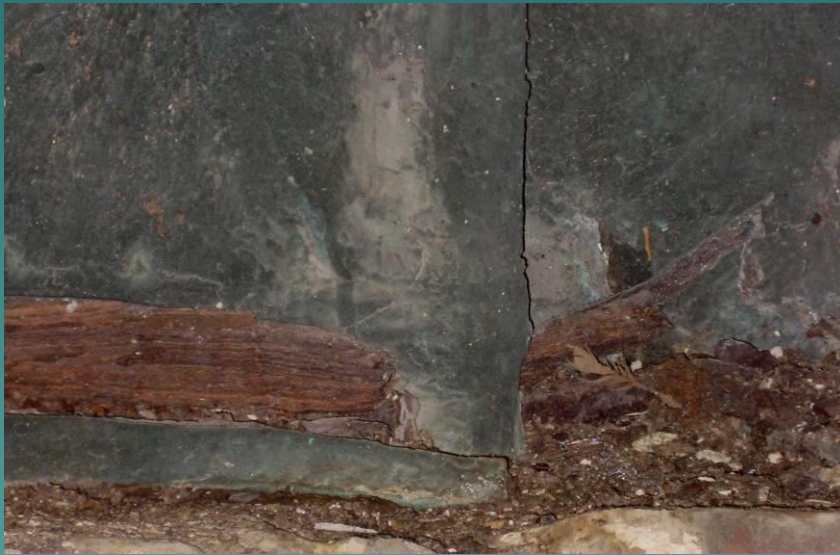
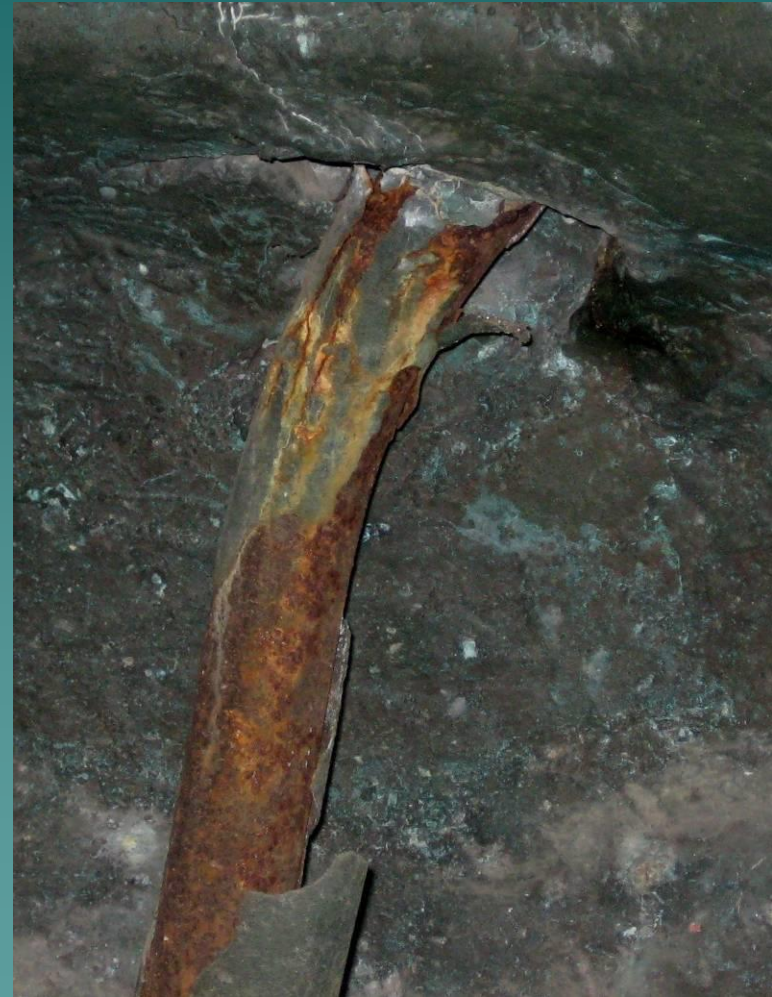
The iron base-ring is heavily corroded partially consisting of layered rust and partially already vanished.

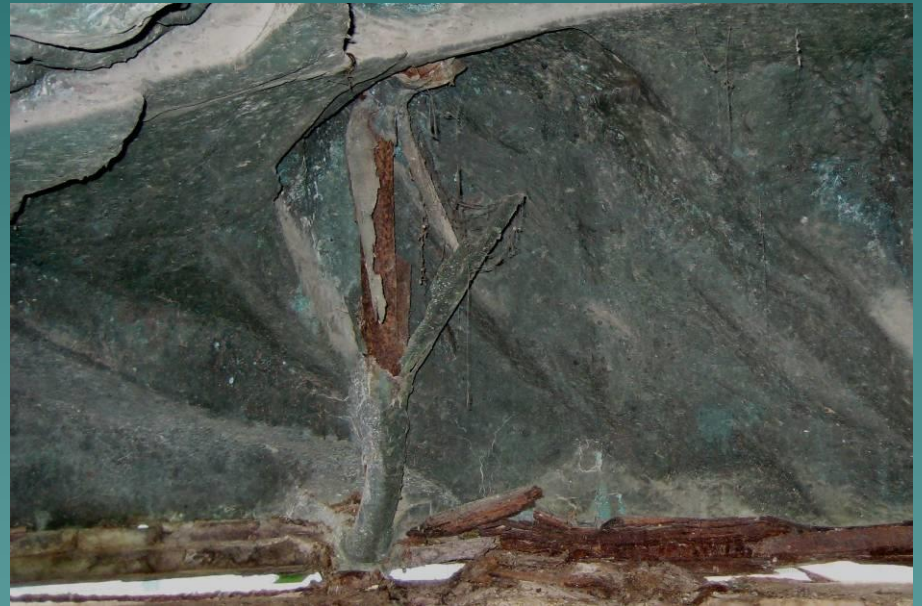
- ◆ The iron stilts, which were covered by a galvanic coating, are corroded, too.
- ◆ the stilts lost the ability to bear the weight of the sculpture. As a consequence
- ◆ the stilts caved in and the galvanic coating burst off as it is shown on the images.

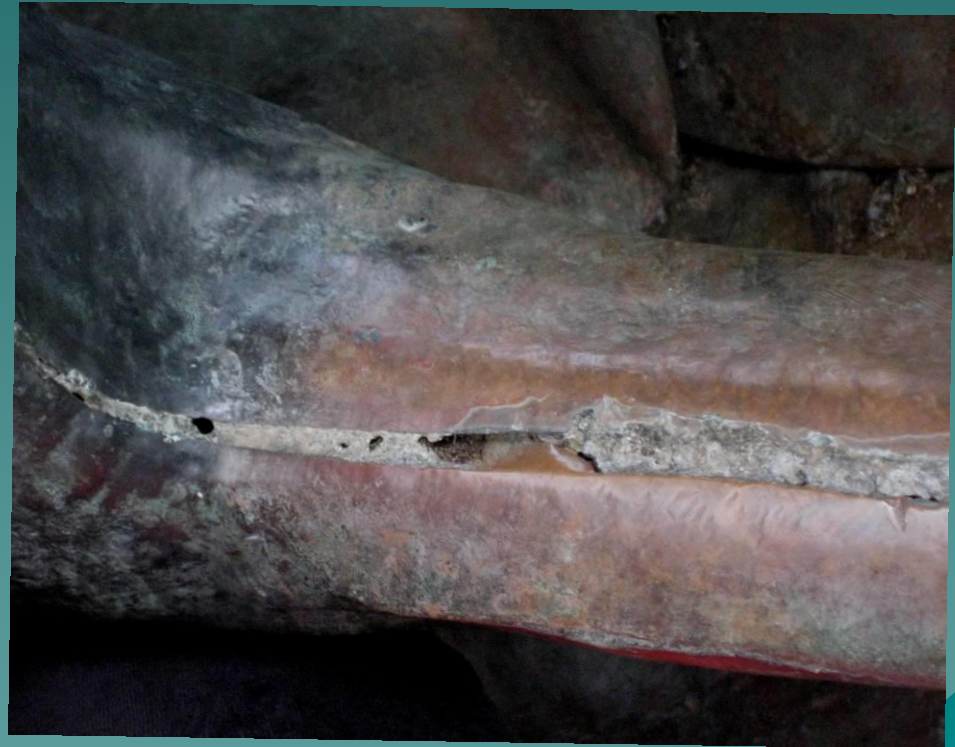
- ◆ This burst fissure is a clear indication for a transversal and lateral shift of the upper part of the monument.
- ◆ If this process will proceed, it can be expected that the complete sculpture will lose its integrity and will break down some day.

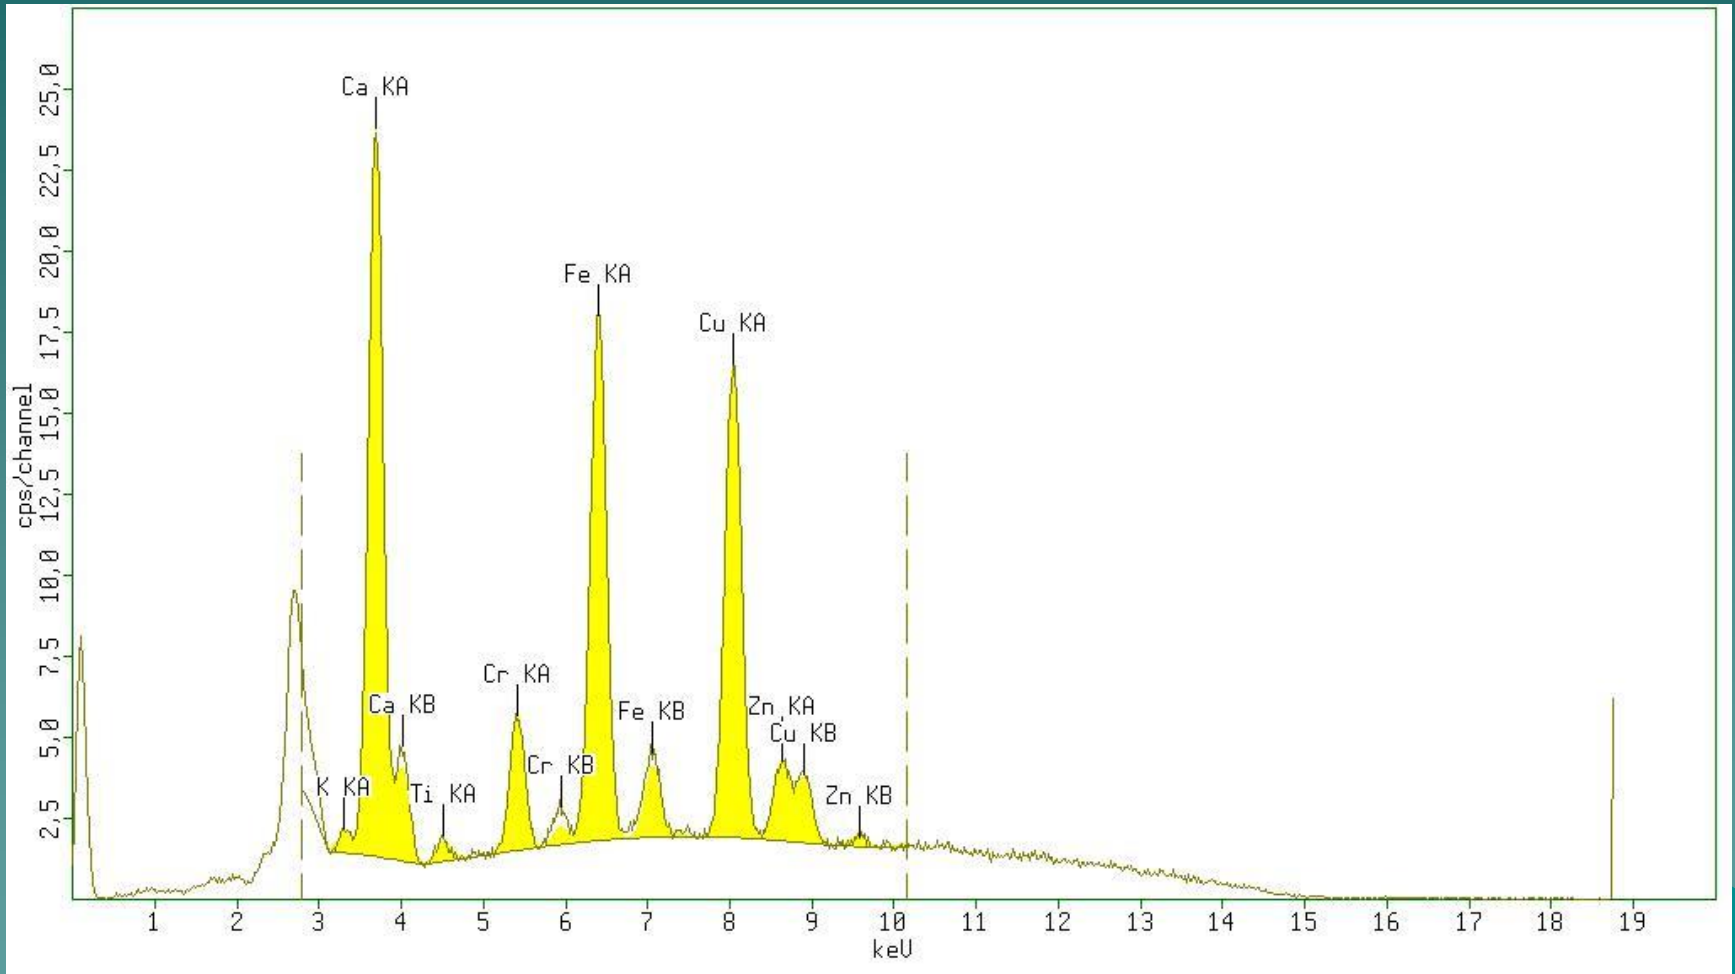
Filling material “putty” inside fissure

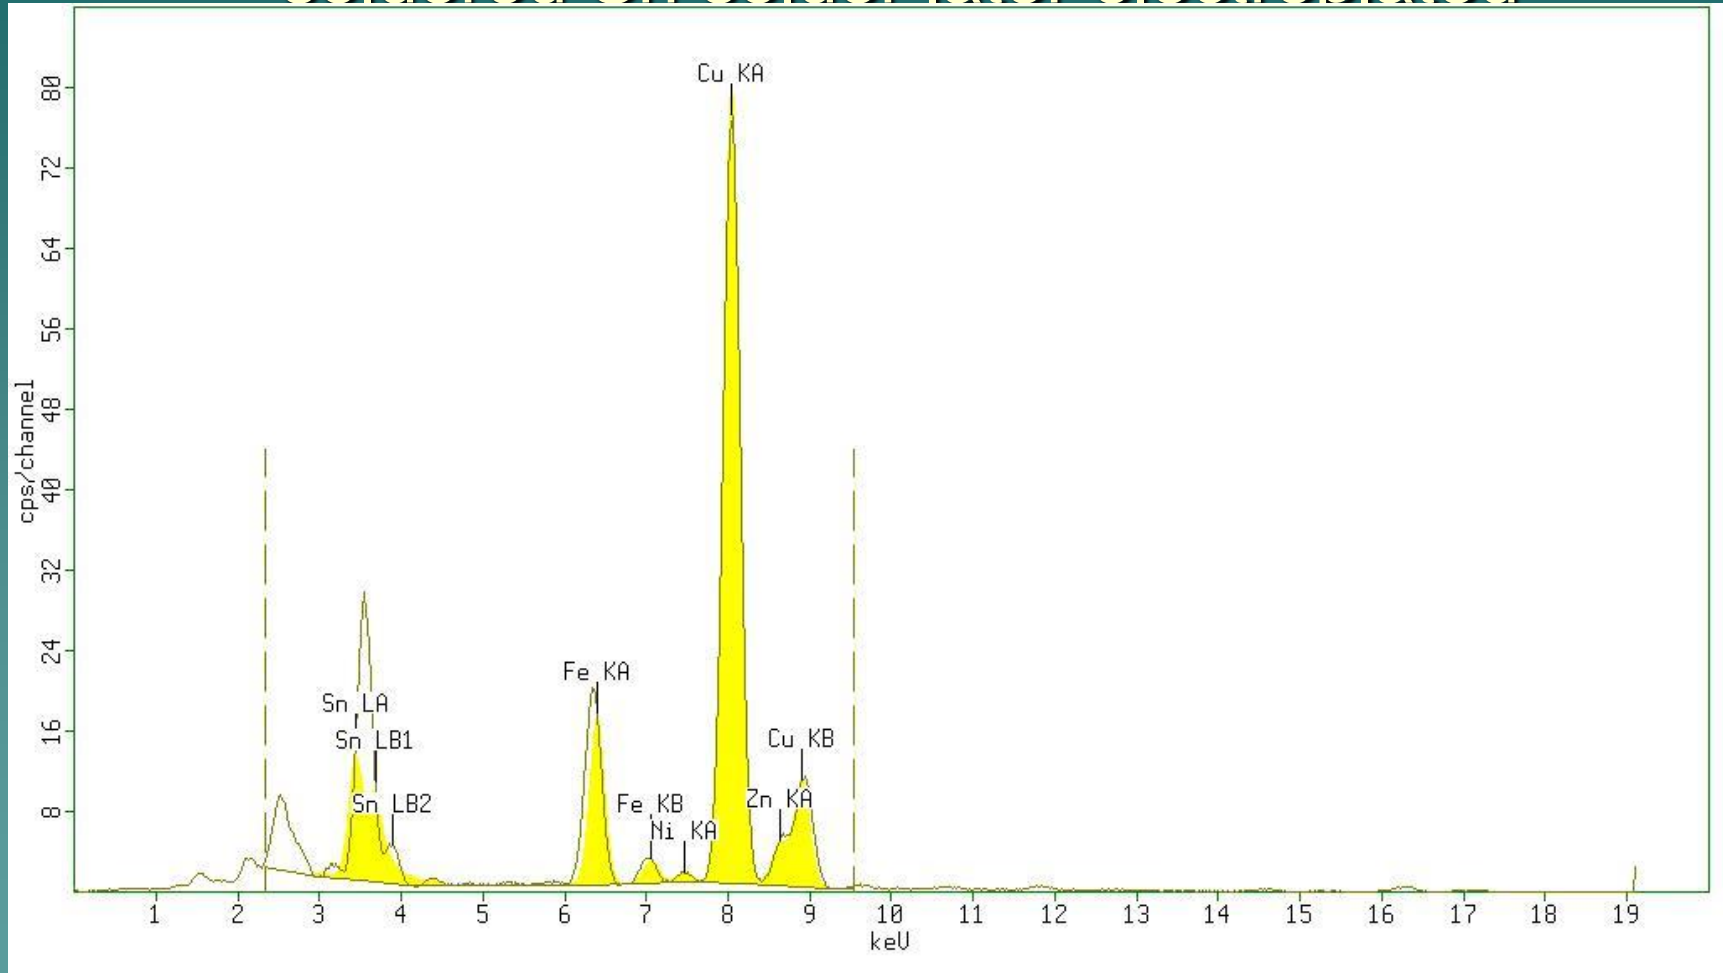
Strap of the Interior Fitting

iron stilts inside the plinth fixed by Cu sheet,
soldered Sn solder later electroplated
